# CRASH INJURY EVALUATION

SUMMARY EVALUATION

U. S. ARMY HU - 1A

FLIGHT SAFETY FOUNDATION, Inc.

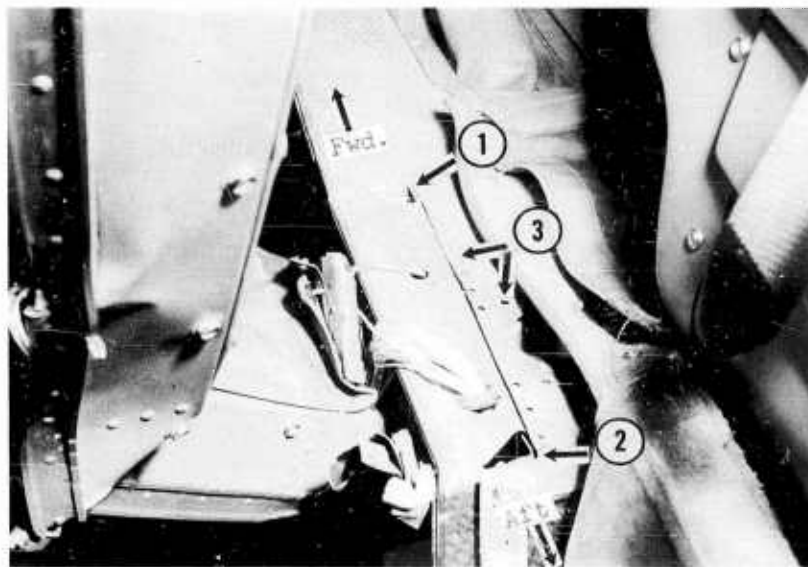
Figure 3. Vertical side support failure in Accident "A". The vertical side support failed at its lower attachment points. The triangular cutouts (arrows 1 and 2) allow the "L" stringers to pass through the floor vertically. The "L" stringers and the inner and outer skin of the support member attach the member to the fuselage. The line of rivet holes (arrow 3) indicate where the skin attaches to the floor.

It is evident, therefore, that the strength requirements of both the main side supports and the aft bulkhead support are inadequate. They should be able to withstand impact forces and conditions of a survivable nature without gross failure. This apparently has been recognized recently by both the military and the manufacturer. "Requests for Alteration" have been studied by the Bell Helicopter Corporation on each of these two features.

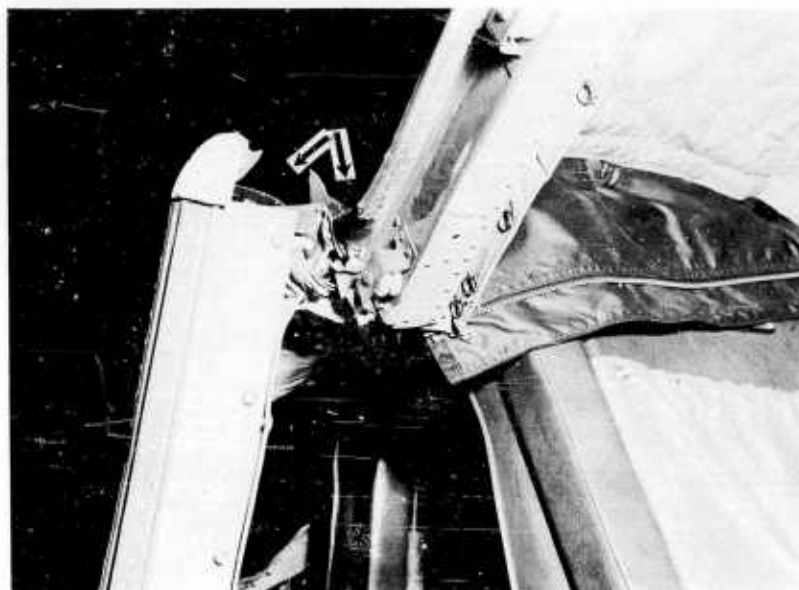
Figure 4. Upper attachment failure of the left vertical side support in Accident "A".

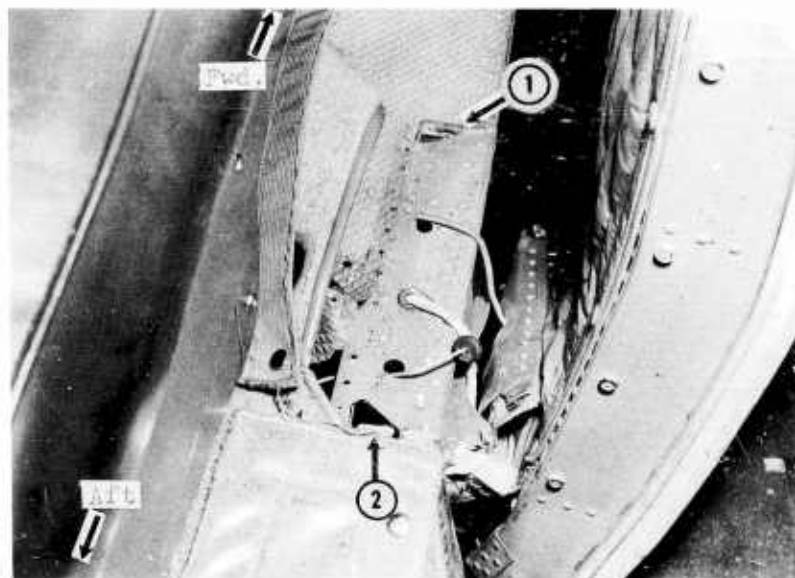
Figure 5. Right vertical support member, lower attachment point, failure in Accident "A". Depth and type of failure of the forward "L" stringer is shown by Arrow 1 (as compared to that of the aft "L" stringer). Arrow 2 indicates some application of force against the upper area of the member in an aft direction during its failure.

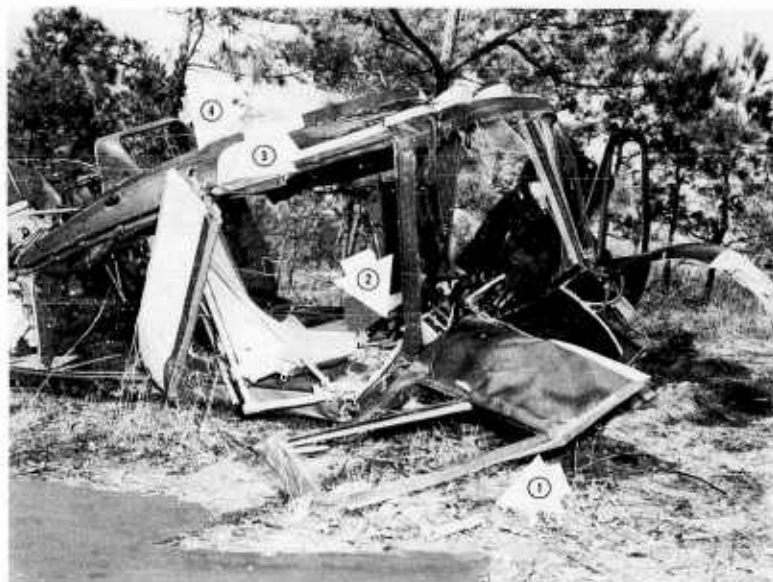
Figure 6. Right side support failure in Accident "B". The upper right side support (arrow 3) was torn free, the bottom also failed. Arrow 1 depicts the pilot's right anti-torque pedal, Arrow 2 damage to collective pitch, while Arrow 4 denotes a hole in the roof caused by the pilot's seat as the roof collapsed.

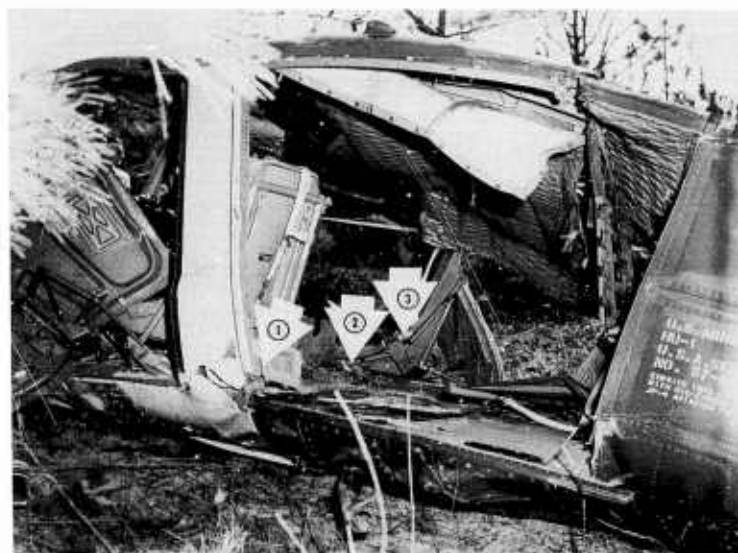
Figure 7. Left side support failure in Accident "B". Arrow 1 depicts the failure on the bottom of the left side support. The top remained attached. Arrow 2 depicts the broken seat attachment, Arrow 3 shows the bent seat tube support.

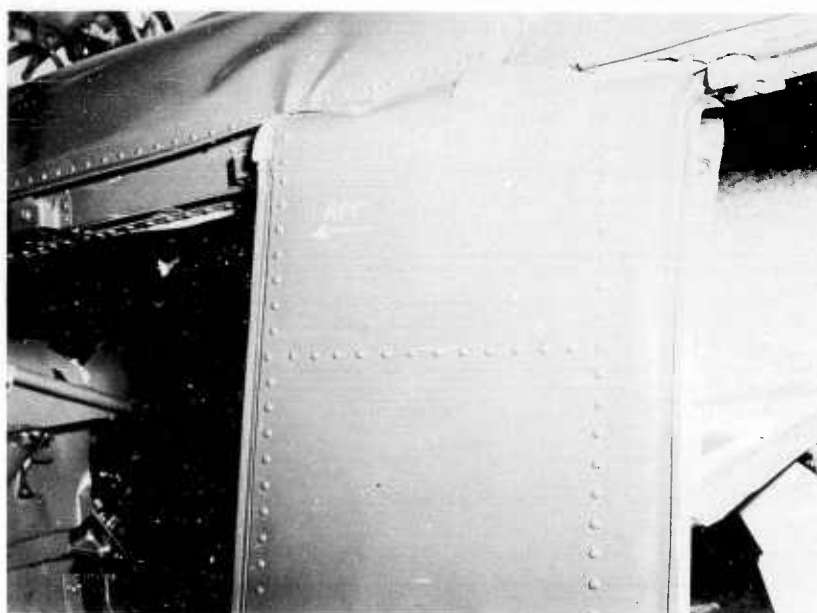
Figure 8. Failure sustained by the top of the right side support in Accident "C".

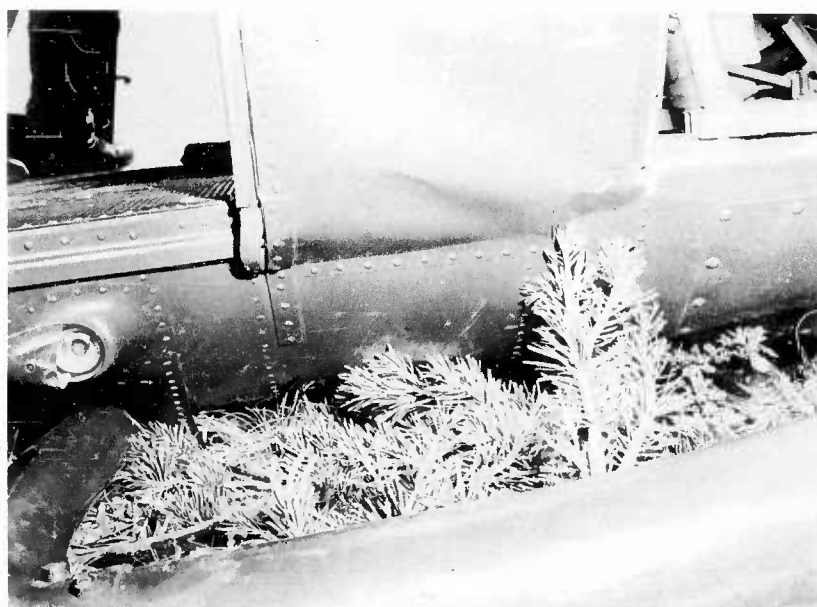
Figure 9. The bottom right side support partially failed in Accident "C".

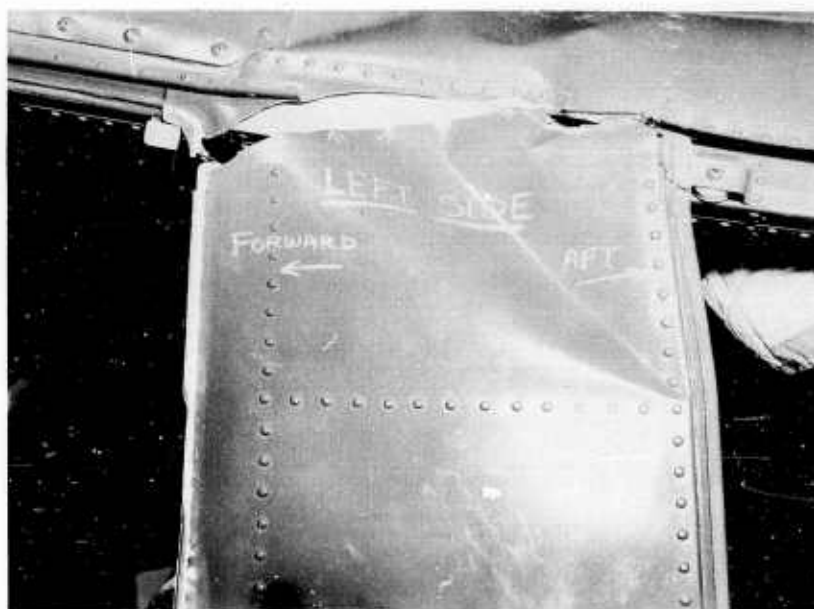
Figure 10. The top of the left side support failed in Accident "C".

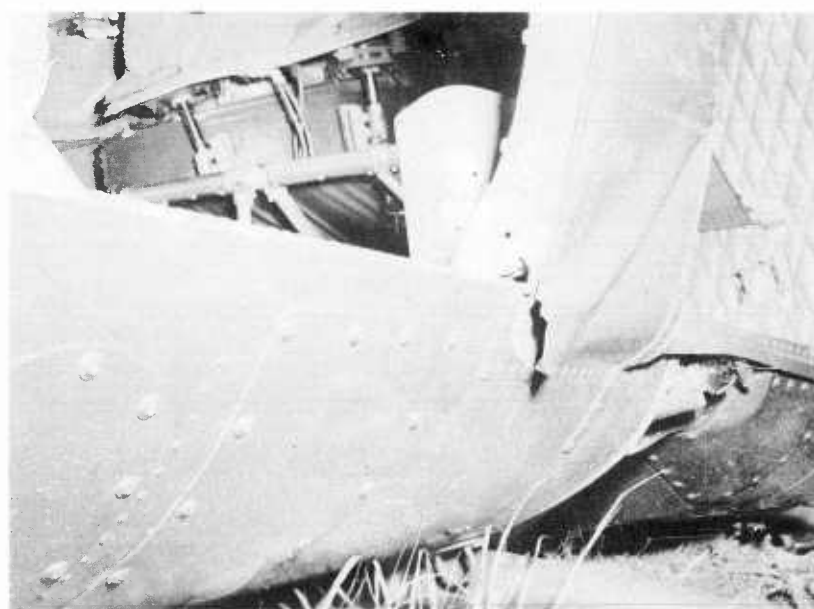
Figure 11. The bottom of the left side in Accident "C" showed signs of failure.

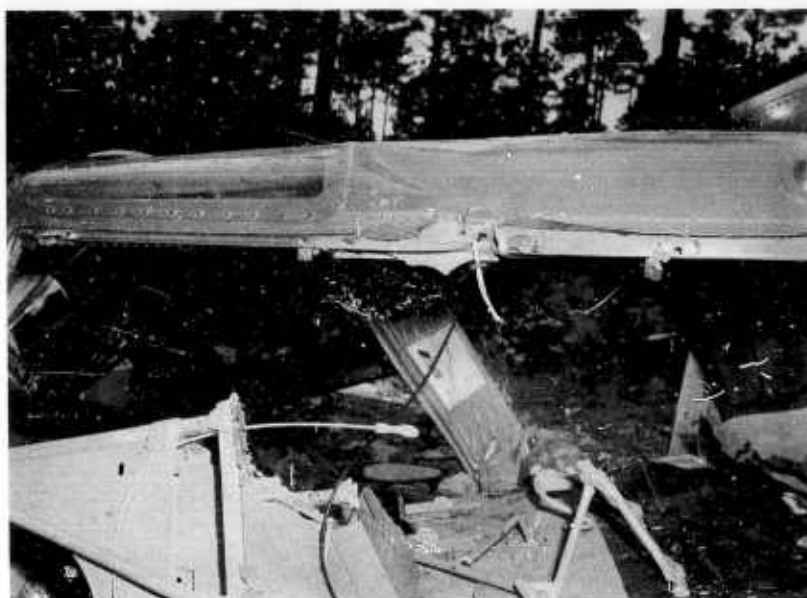
Figure 12. The top left vertical side support was torn completely free in Accident "D".

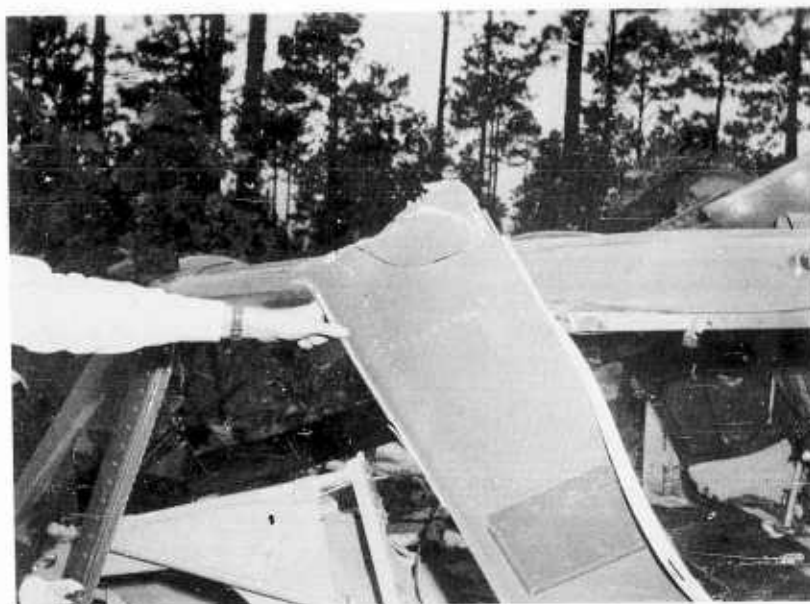
Figure 14. Side view of the torn free support in Accident "D", left side.

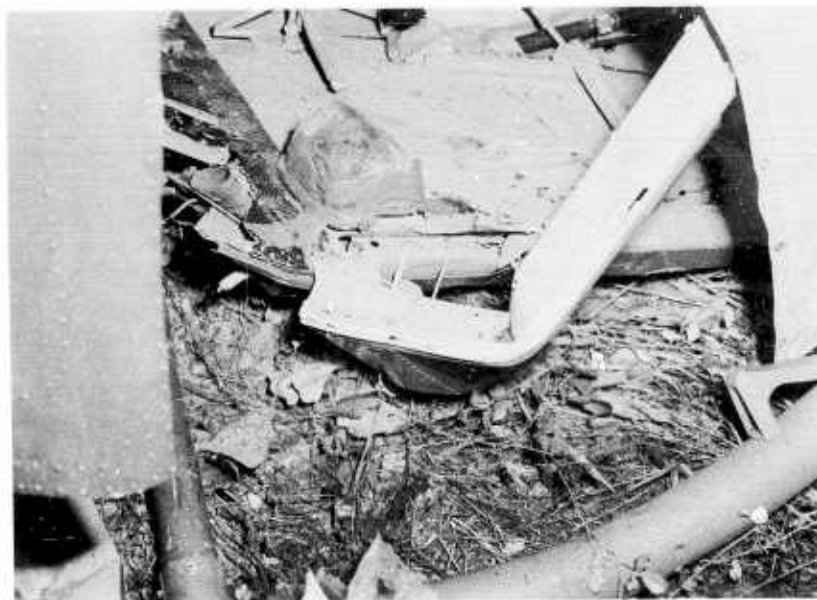
Figure 16. Wiring supported the bottom on the right side support in Accident "D".

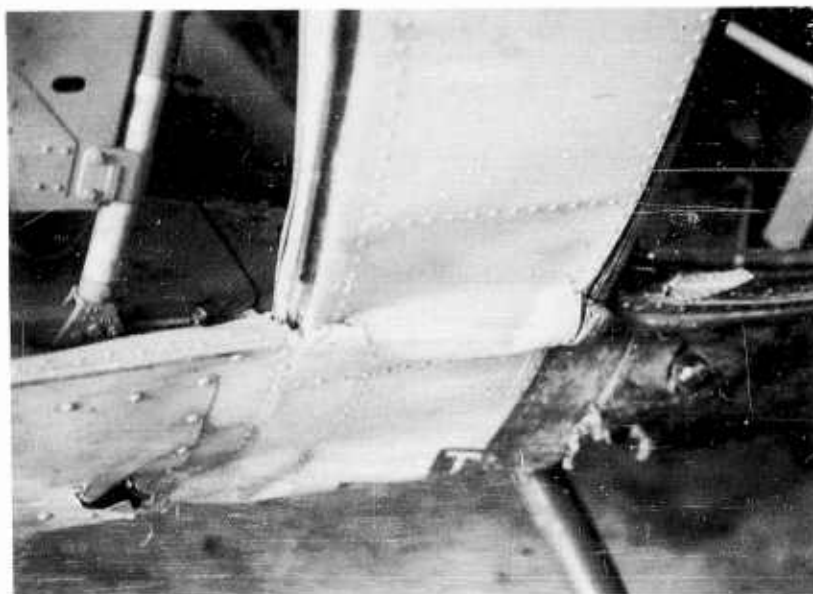
Figure 17. Bottom of the left support in Accident "E" (aircraft fell on its left side). Partial failure may be noted in the side supports.

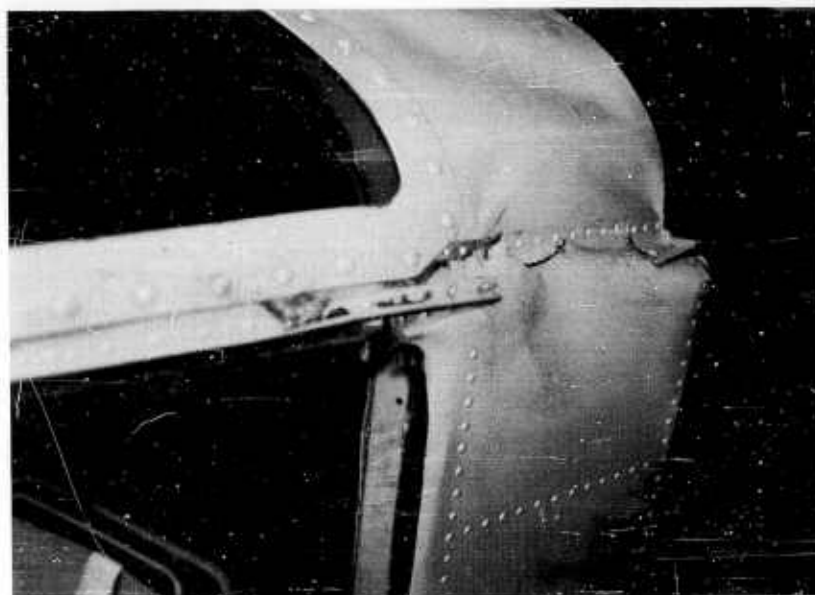
Figure 18. Partial failure occurred on the top of the support, left side, in Accident "E".

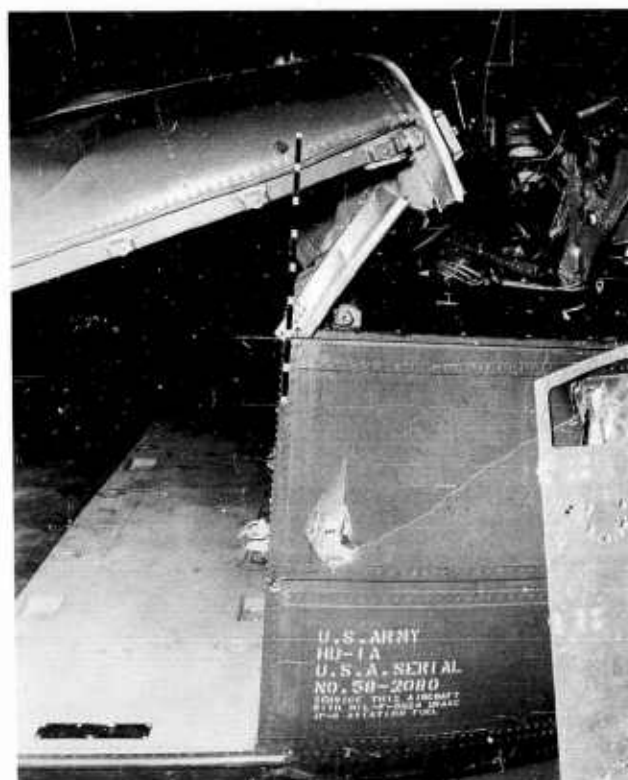
Figure 19. The downward collapse of the roof in Accident "A" is shown. The dotted line depicts the normal position of the fire wall.

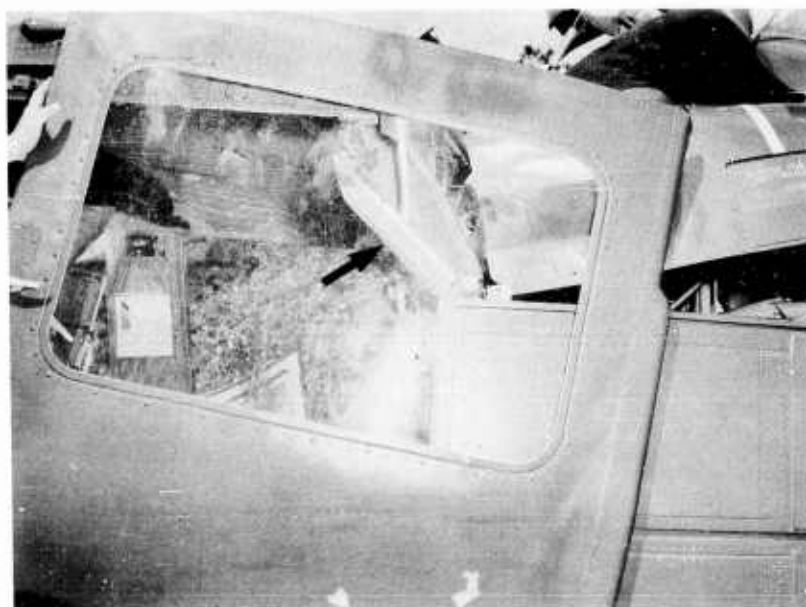
Figure 21. The arrow depicts the forward movement of the aft bulkhead, left side, in Accident "C".

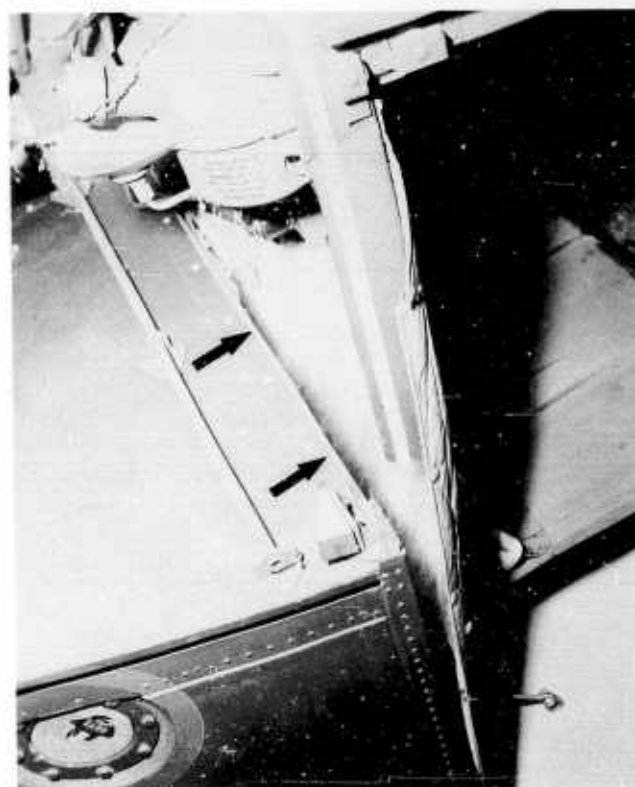
Figure 22. The aft roof structure failed on the right side in Accident "C".

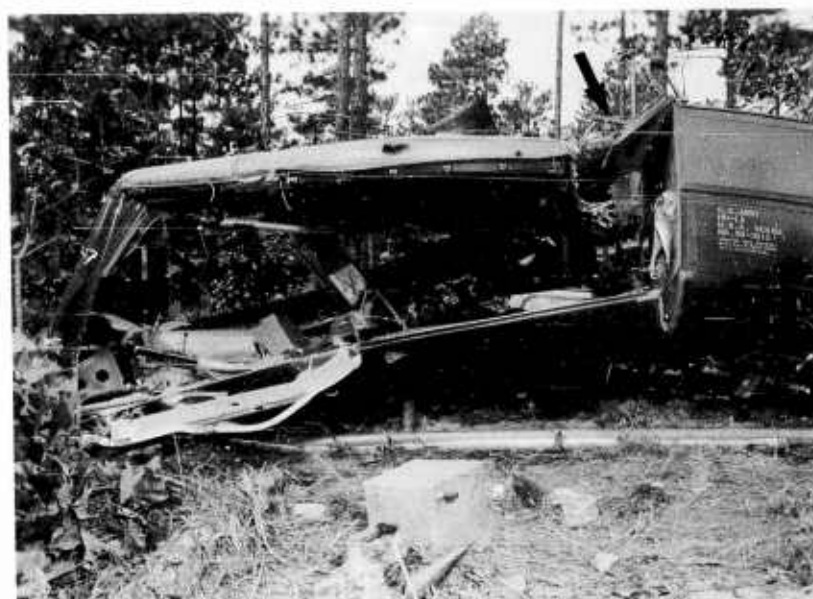
Figure 23. Wiring was the remaining support of the roof structure in Accident "D".

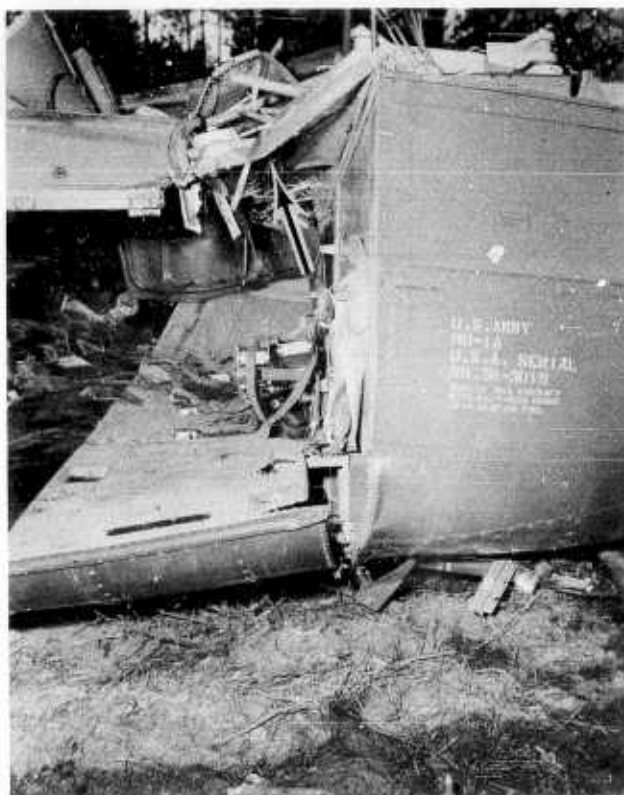
Figure 24. The forward displacement of the aft roof support is depicted by the arrow, Accident "D".

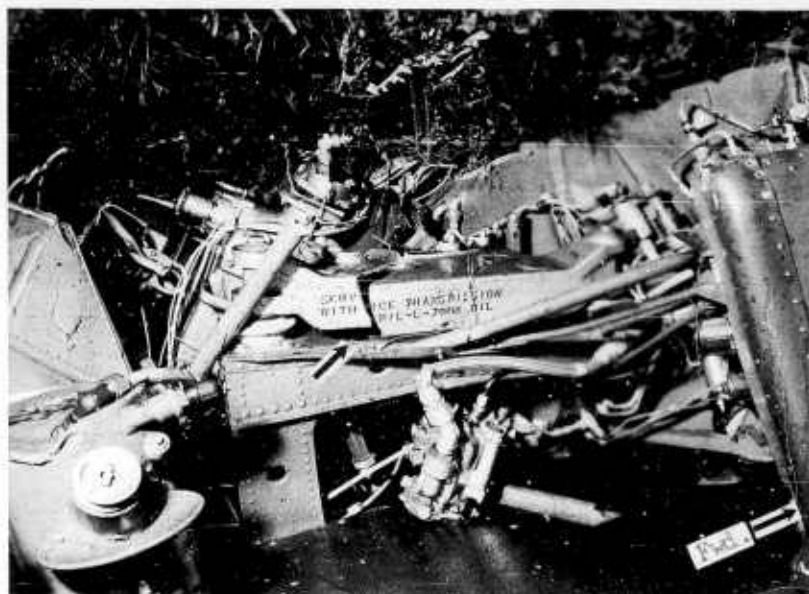
Figure 25. The arrow depicts the failure in the transmission mount which occurred in Accident "A". The transmission, mast, and rotor assembly were partially torn free as a unit.

Considering the loads for which the transmission is stressed and the fact that a failure occurred in every accident including the YH-40 at Fort Rucker, it is believed that an inherent deficiency in structural design exists.

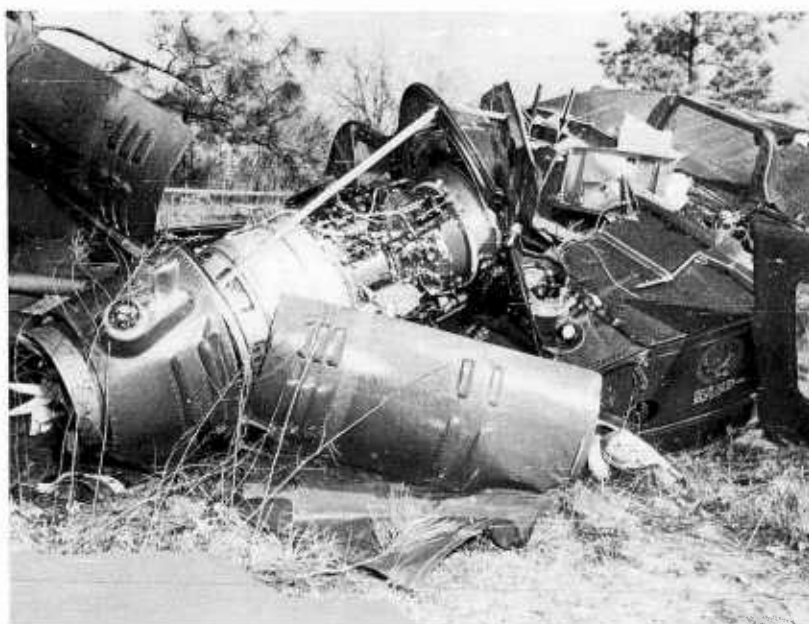
Figure 26. The entire unit was torn free when the blades contacted a tree in Accident "B". The arrow depicts the area normally occupied by the transmission.

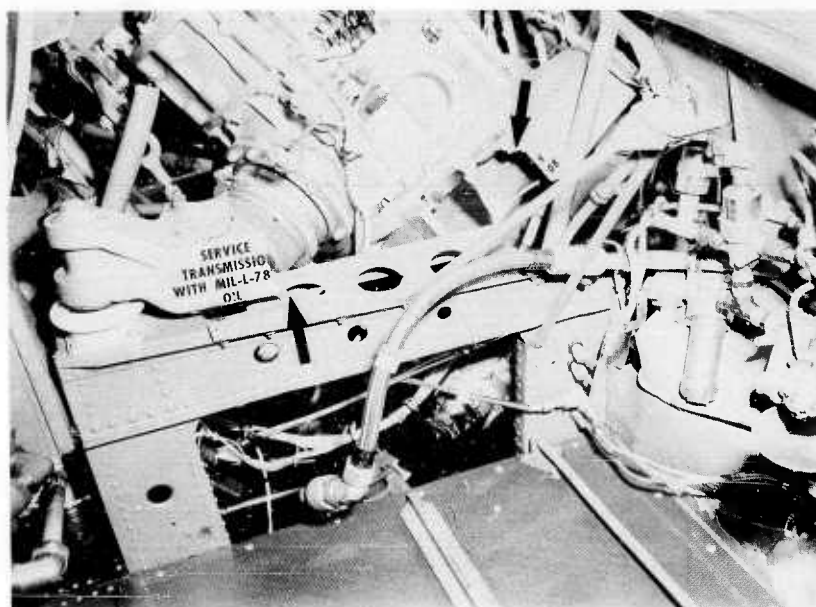
Figure 27. The arrows depict the fractures in the transmission mounts which occurred in Accident "C".

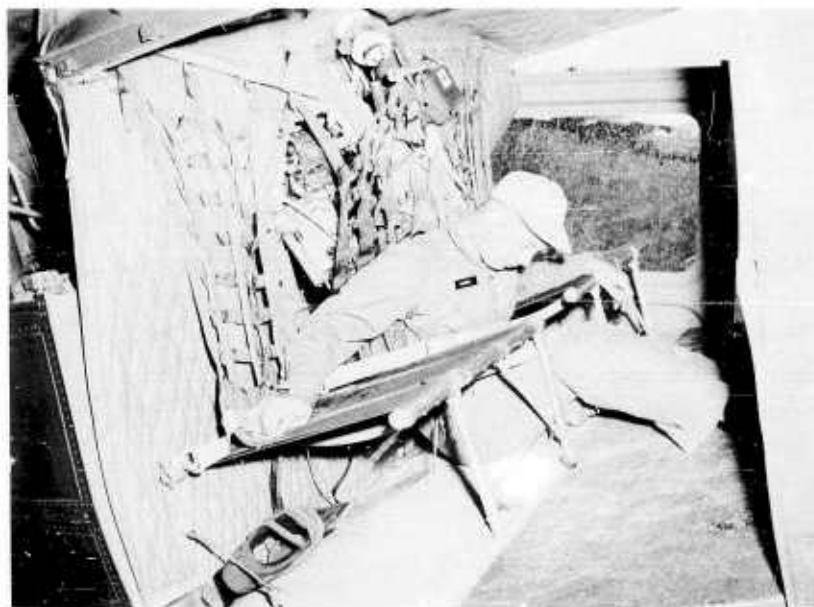
Figure 28. In Accident "C" the transmission penetrated 17 inches into the occupiable area. The loosely worn safety belt plus the failure of the seat permitted the occupant to bottom as depicted in this posed photograph.

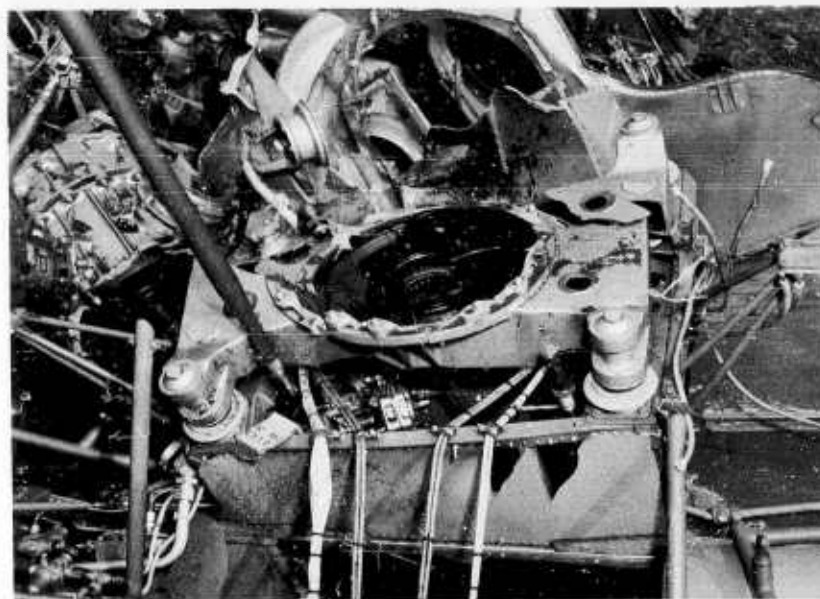
Figure 29. The entire transmission was torn free in Accident "D".

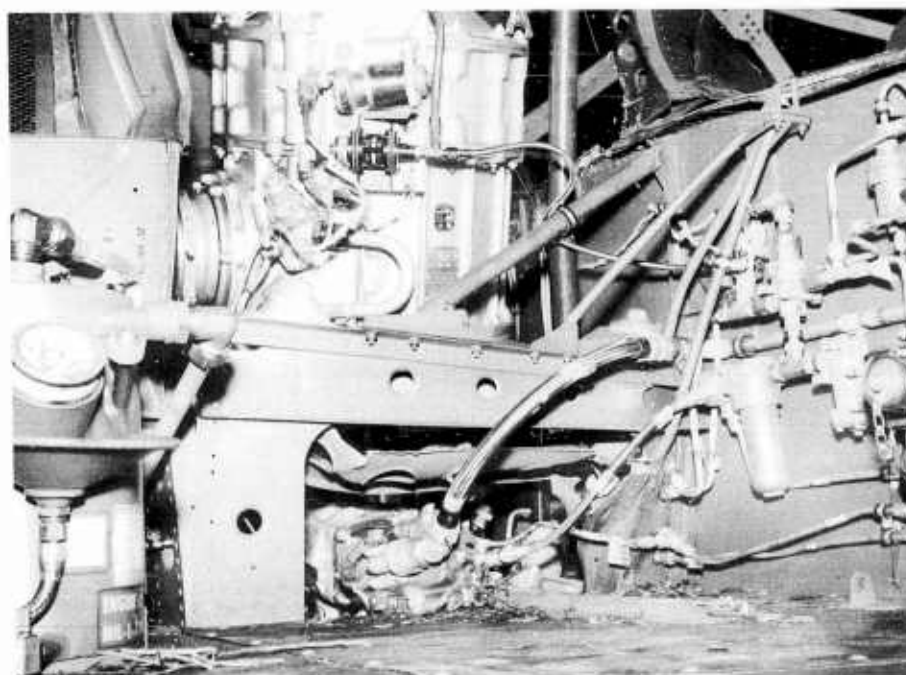
Figure 30. The transmission was displaced in Accident "E".

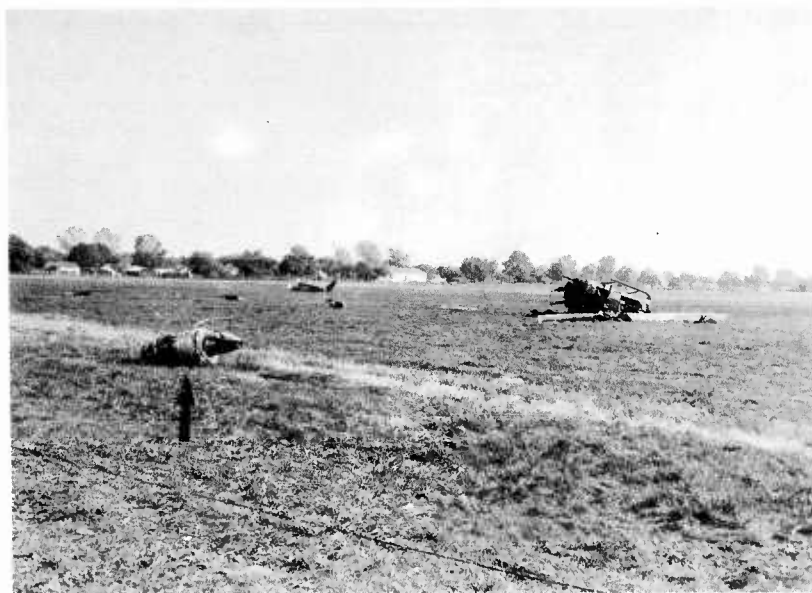
Figure 31. The arrow depicts the engine, torn free, in Accident "A".

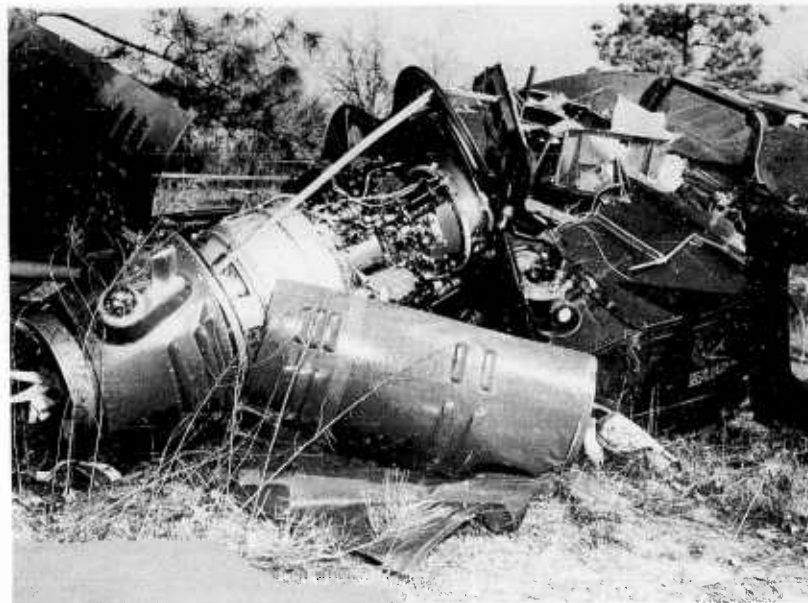
Figure 32. A partial failure in the engine mounts occurred in Accident "B".

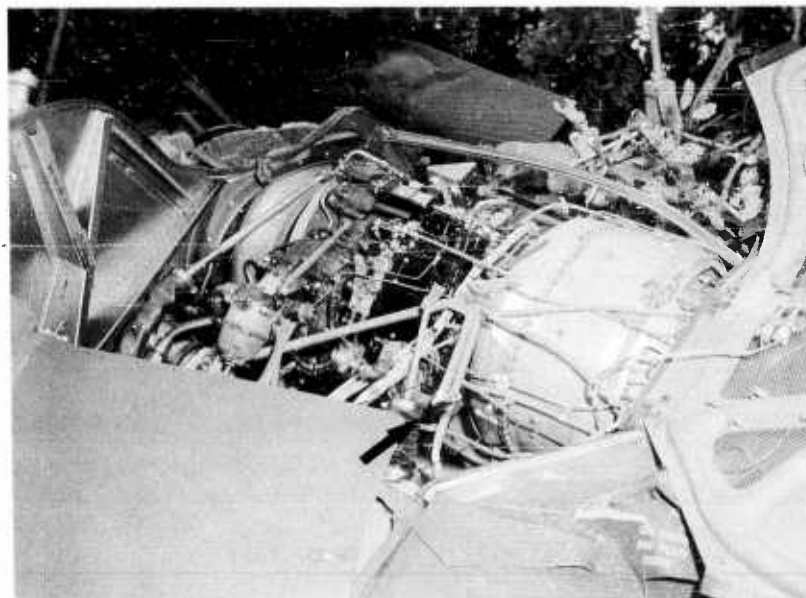
Figure 33. The arrow depicts a partial failure in the engine mounts in Accident "D".

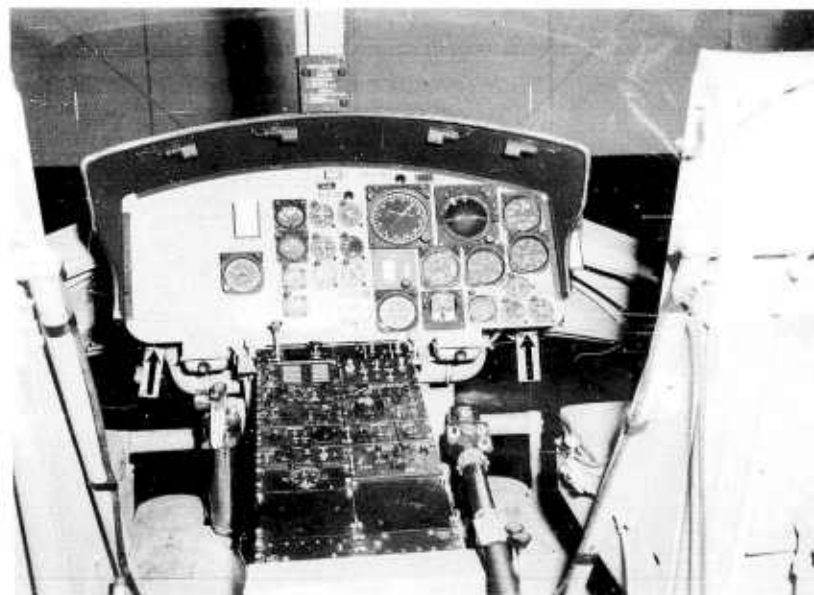
It should be noted that the lower edges of the instrument panel (Figure 34) are quite sharp and unprotected. Statistics reveal that the lower extremities receive the second largest percentage of injuries. The lower edges of the instrument panels should, therefore, be padded with a high energy absorbing material.

Figure 34. Over-all view of the instrument panel in the HU-1 and HU-1A. The arrows denote the sharp unprotected lower edges of the instrument panel.

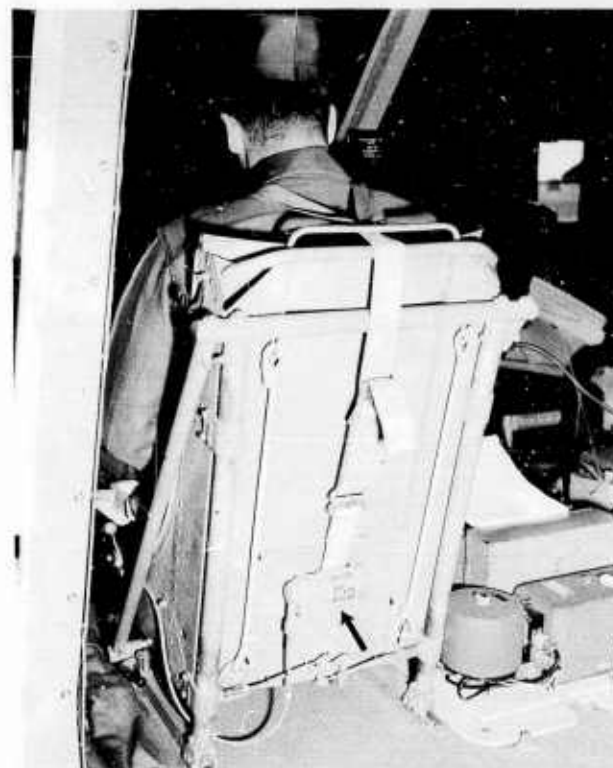
Figure 37. The arrow depicts the inertia reel attached to the rear of the seat. Note the width of the shoulder harness guide at the top of the seat. This is considered excessive.

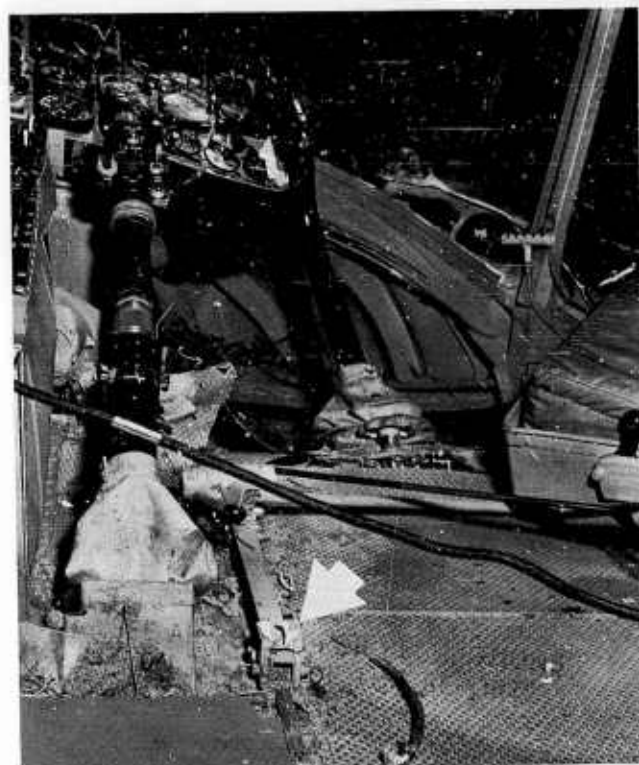
Figure 38. The pilot's seat failed in Accident "B". The arrow points out the failure which occurred at the casting.

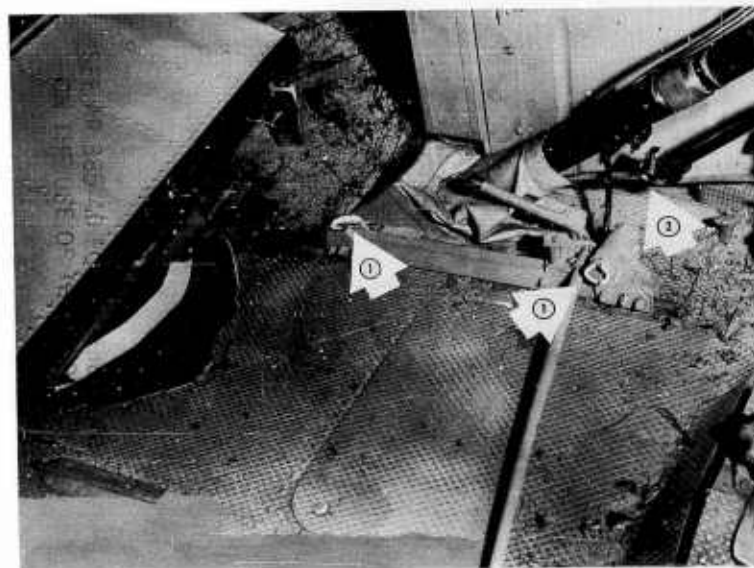
Figure 39. Side view of the failures in Accident "B". The rear attachment failed at the casting (arrows 1) while the front failure occurred at a drilled point in the front cross-tube. Arrow 2 depicts the broken collective pitch.

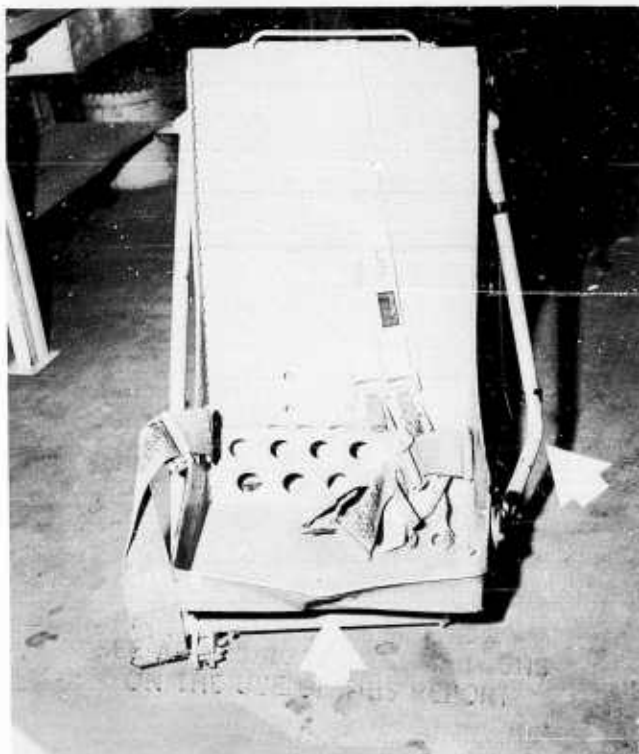
Figure 40. Damage to the pilot's seat pan in Accident "B". The bottom arrow depicts the distortion sustained by the seat pan. The side arrow points out the distortion to the seat tube, Accident "B".

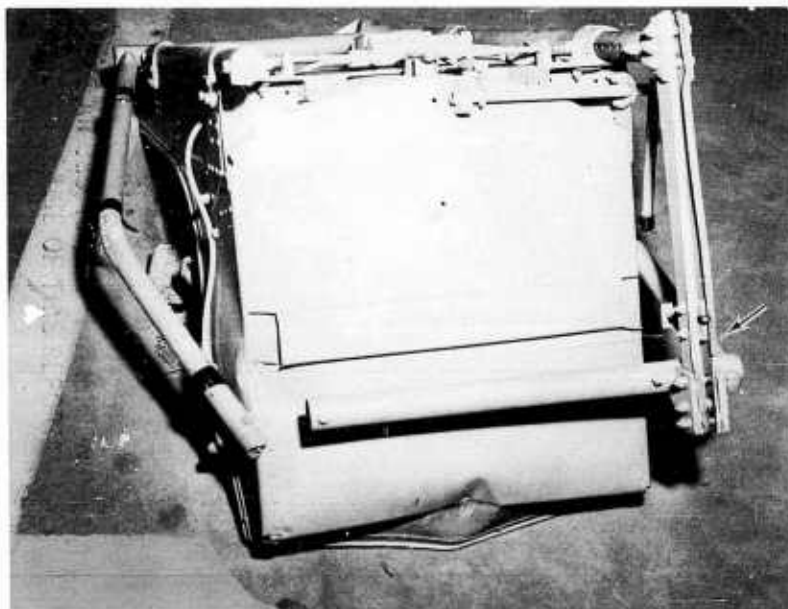
Figure 41. Seat carriage in Accident "B". The arrow depicts the spreading of the seat carriage permitting the seat to separate from the track.

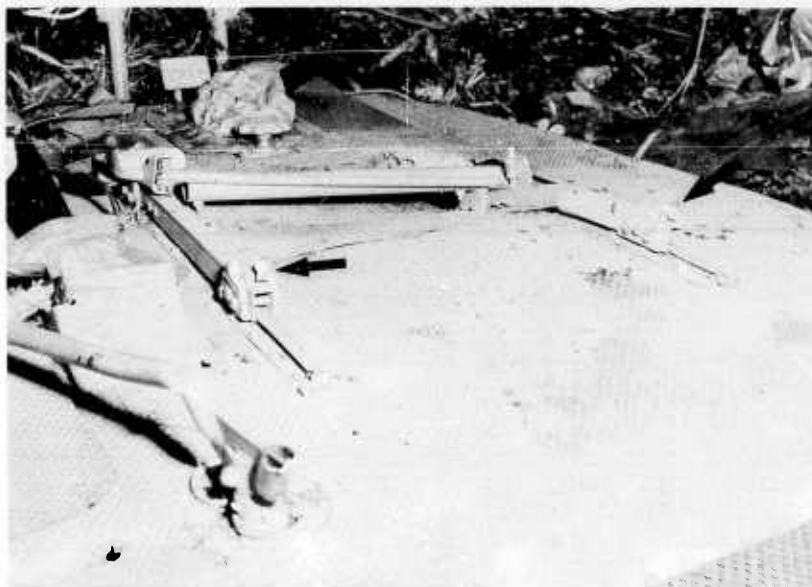
Figure 42. The arrows denote the failures in the leg castings in Accident "D" (right seat). Note the similarity in the failures in this accident with those in Accident "B".

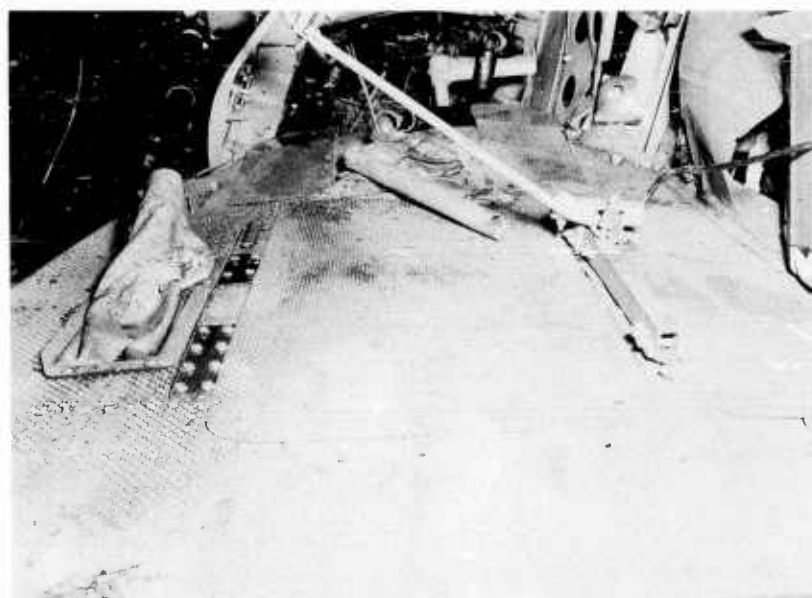
Figure 43. Left seat failure in Accident "D". The right rear leg tore free from the carriage while the left rear leg ripped the track from the floor, permitting the seat to pivot forward. The front attachments were torn free by rescue personnel.

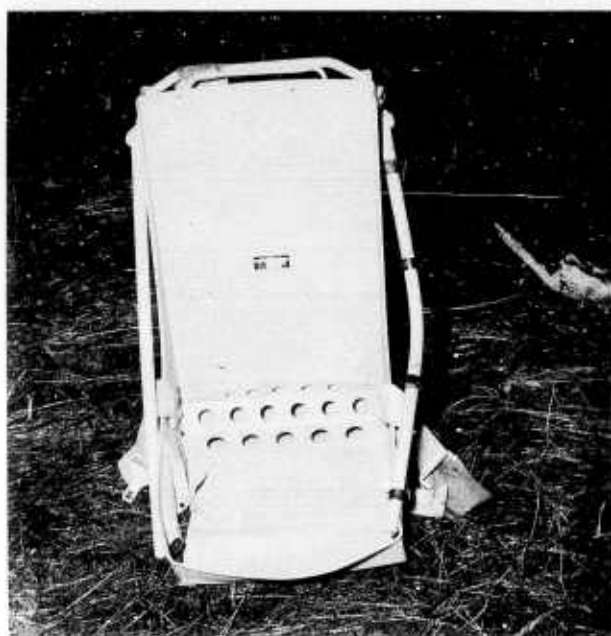
Figure 44. The pilot's seat, right side, in Accident "D". Note the similarity in the damage with the seat in Accident "B".

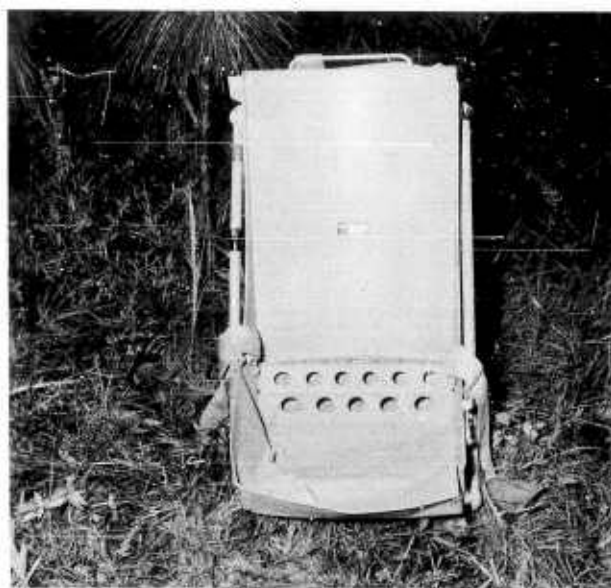
Figure 45. Damage to copilot's seat, left side, in Accident "D".

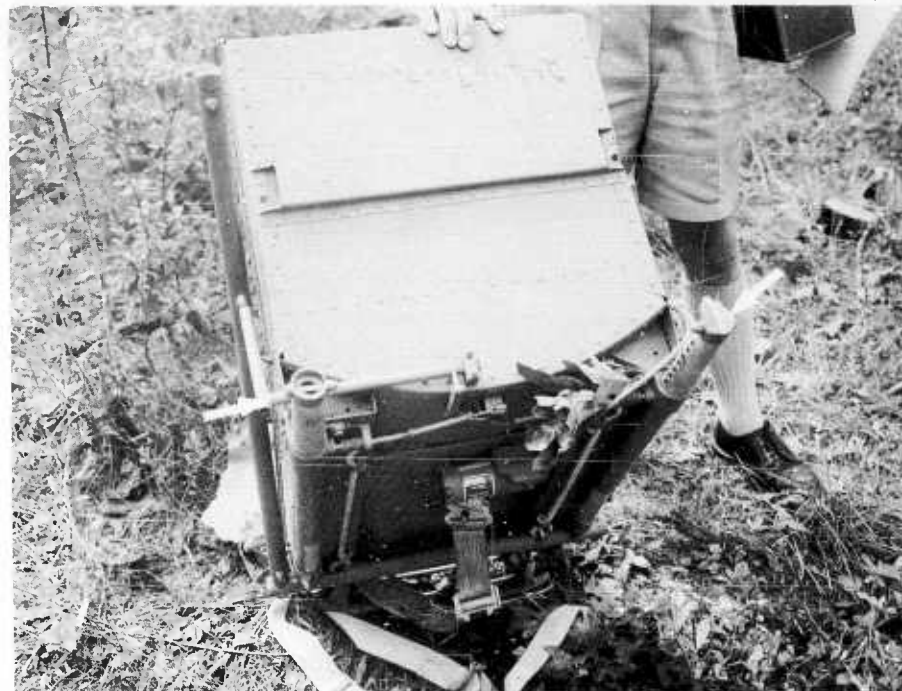
Figure 46. In Accident "E", failures occurred in the leg casting and also at a drilled point (arrows).

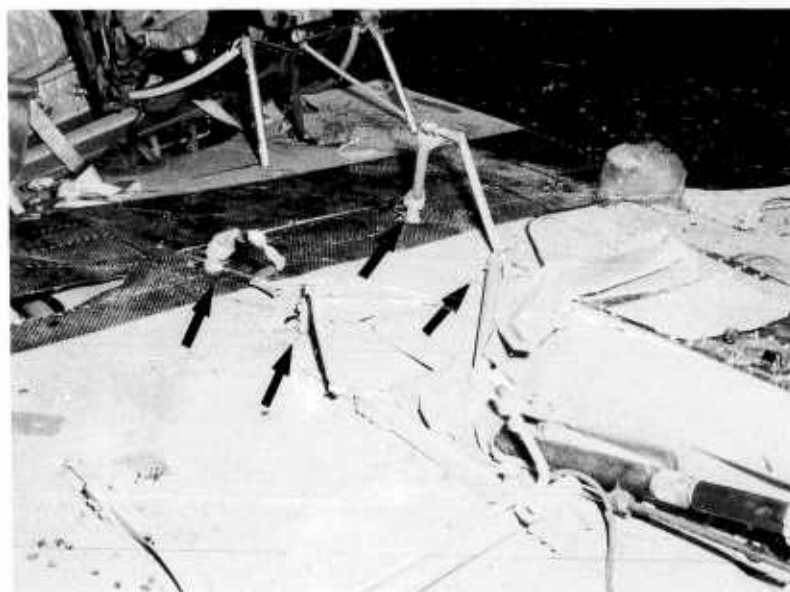
Figure 48. Crew chief seat failure in Accident "D". The arrows depict failures of the leg structure.

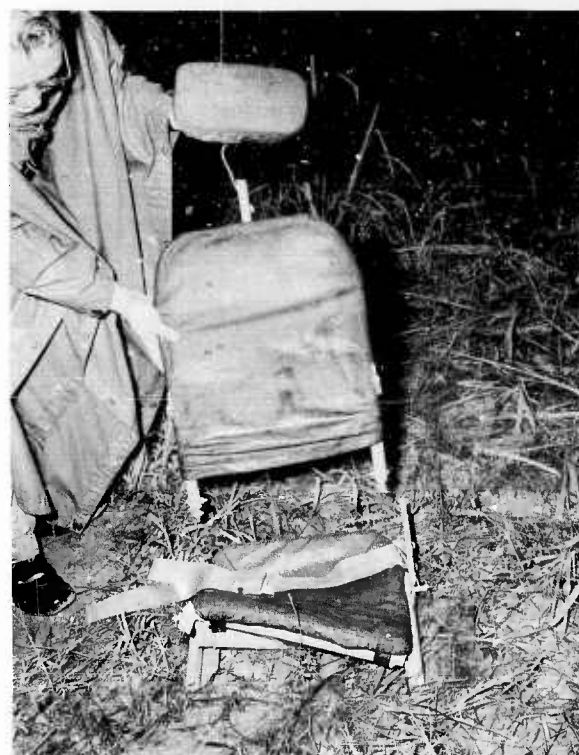
Figure 49. Damaged crew chief's seat.

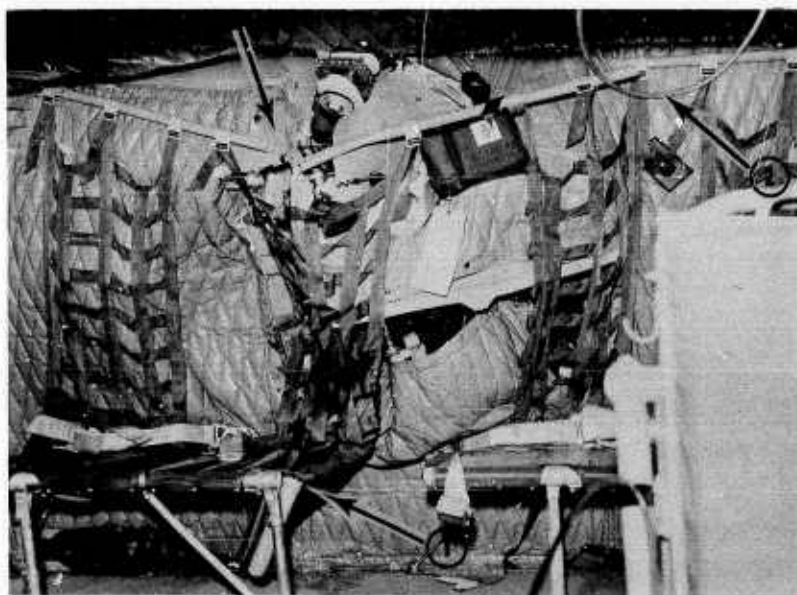
Figure 50. Cabin seat failure in Accident "C". Arrow (1) denotes the failure in the forward cross-tube. Failures also occurred in the cross-tube which supports the seat back due to the penetration of the transmission (arrows 2, 3).

Accident experience has proven that MIL-S-5804A requires revision to provide strength requirements compatible with survivable crash force magnitudes, directions, and time duration. Furthermore, the troop seat should be subjected to dynamic testing in order to obtain a more realistic appraisal. The cabin area in Accidents "A" and "B" was unoccupied; therefore, no seat failures occurred. In Accident "E" the seats were folded and replaced with a ferry tank.

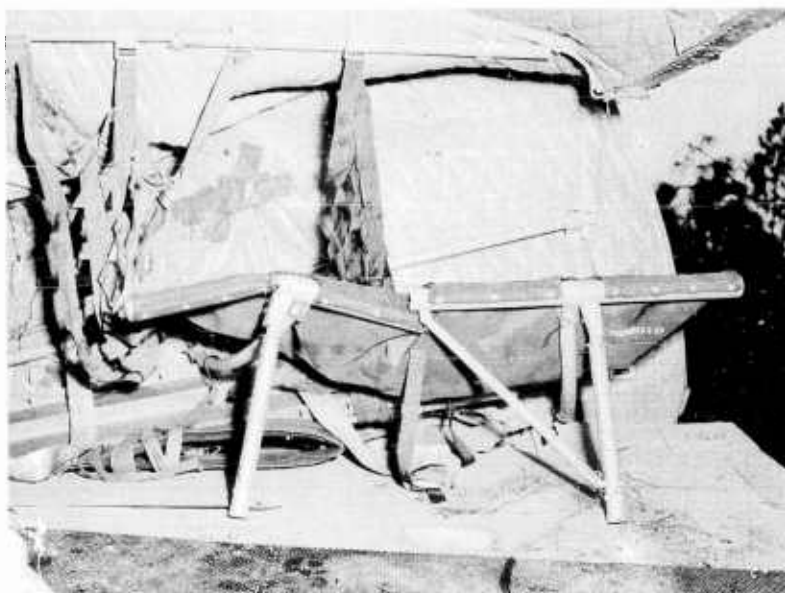
Figure 51. In Accident "D" both seats on the left side were completely collapsed and broken. The seat was set up for photographic purposes.
